# Manhole Inspection Summary

Manhole # S21M\_\_031MH

Insp Date: **3/20/08 1:40 PM**

**Location** Address: **2011 wilkens-eagle alley**

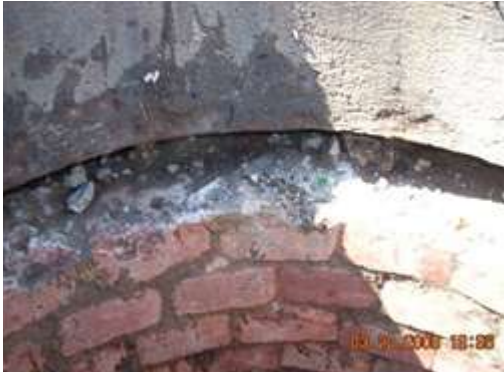
Defect 3

Condition: ☐ Sound ☐ Cracked ☐ Root Intrusion ☒ Loose Brick ☒ Deteriorated

deteriorated chimney

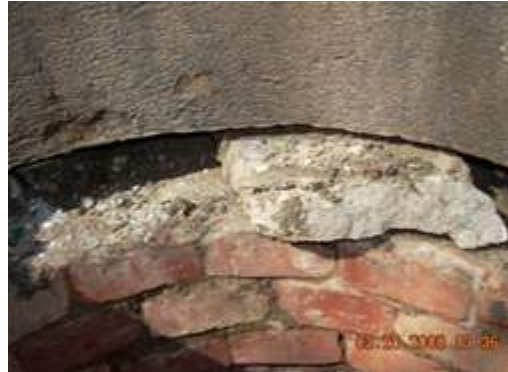
Defect 2

loose concrete chimney adjustment

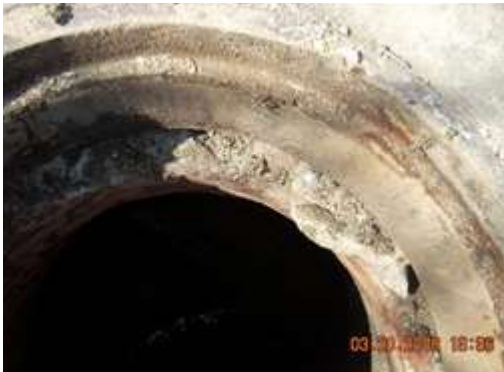
Defect 1

Offset: **2** (in.)

frame offset

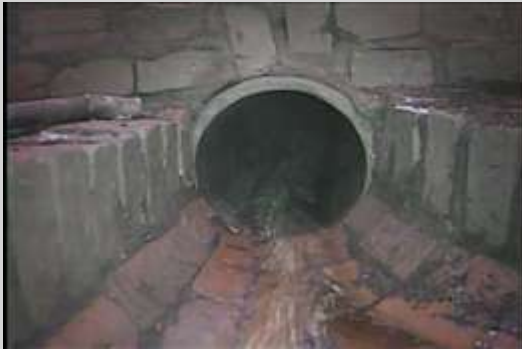
12 O'Clock Outflow

8 in. Circular Gravity Sewer  
Pipe Out @ 12 O'Clock

Pipe Height: **8.4** (in.) Rod and Bar (Angled)  
Pipe Material: **Clay** ☐ Pipe Lined  
Invert Depth: **9.40** (ft.) Flow Characteristics: **Slow**  
Deposits: ☒ None ☐ Mud ☐ Sludge ☐ Debris ☐ Grease  
Silt Depth: **0** (in.) Deposits Extent:  
Infiltration: **None** Pipe Seal Cond: **Sound**

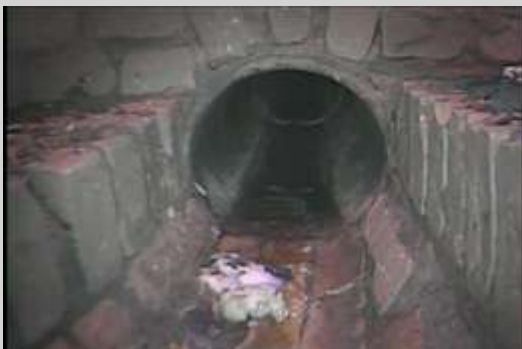
3 O'Clock Inflow

8 in. Circular Gravity Sewer  
Pipe In @ 3 O'Clock

Pipe Height: **8.4** (in.) Rod and Bar (Angled)  
Pipe Material: **Clay** ☐ Pipe Lined  
Invert Depth: **9.29** (ft.) Flow Characteristics: **Slow**  
Deposits: ☒ None ☐ Mud ☐ Sludge ☐ Debris ☐ Grease  
Silt Depth: **0** (in.) Deposits Extent:  
Infiltration: **None** Pipe Seal Cond: **Sound**

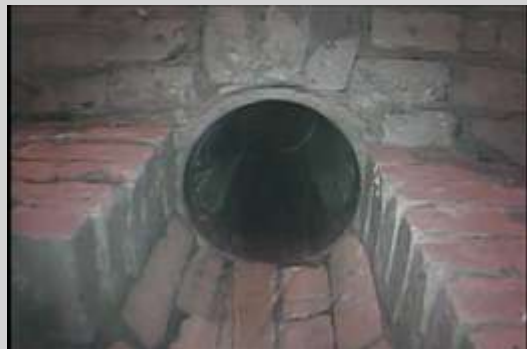
6 O'Clock Inflow

8 in. Circular Gravity Sewer  
Pipe In @ 6 O'Clock

Pipe Height: **8.4** (in.) Rod and Bar (Angled)

Pipe Material: **Clay** ☐ Pipe Lined

Invert Depth: **8.97** (ft.) Flow Characteristics: **Slow**

Deposits: ☒ None ☐ Mud ☐ Sludge ☐ Debris ☐ Grease

Infiltration: **None** Pipe Seal Cond: **Sound**
